Application Note

Reducing RF Leakage Using VIAMI Solutions Antenna Couplers

This application note explains the RF attenuation provided by VIAMI transponder antenna couplers, how to maximize attenuation, and avoid interference with ATC and nearby aircraft.

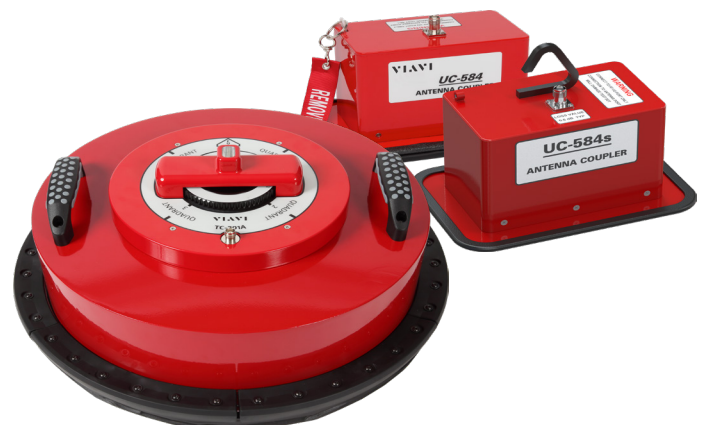
Fig. 1 The potential of creating a False Intruder is based on the coupler RF Leakage, isolation from the hangar, and the relative distance of the Ground Station to the Testing Location

Although VIAMI manufactured antenna couplers are constructed for maximum attenuation, there are multiple test set up variations that can cause RF leakage. Ideally, the couplers conductive gasket works best seated to a metallic (unpainted) surface. Some antennas may be taller and/or have a flange that does not allow for a proper seal. Ball and stub antenna configurations may not allow for proper sealing of the gasket to the aircraft skin, or certain antenna types simply may not be accommodated with available couplers. The aircraft fuselage type (composite vs. aluminum) can also allow for leakage.

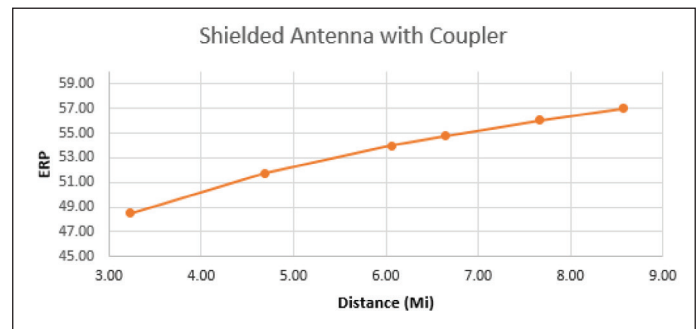
To illustrate the effectiveness of using a coupler on the tested antenna and/or using a coupler as a shield for diversity systems, see below table and graph. This represents a typical attenuation of 25dB provided by the coupler, the RF leakage path loss and resultant distance is as follows. This example is worst case.

The above example does not consider testing inside a hangar, which may provide for additional shielding.

In most cases, the antenna coupler provides adequate attenuation to limit false intruders. But, depending on the ground station's location in relation to your test location, the attenuation provided **may not be adequate to prevent your test event from being picked up by ATC and rebroadcast.**

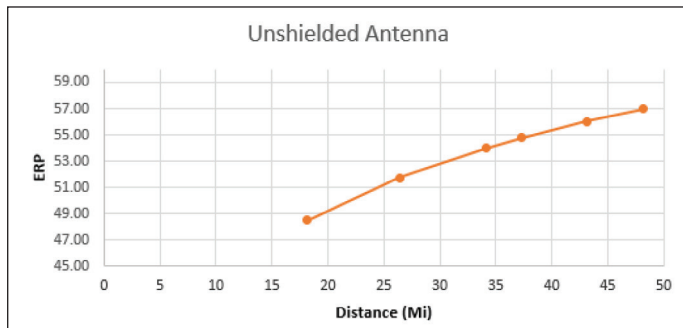
Using the same data points for attenuation, and -74dBm as receiver sensitivity for aircraft equipped with TCAS or ADS-B-In receivers, the below charts indicate how far out the RF signal from your test event will pick up a transmitted DF11 squitter by airborne systems, if not rebroadcast by an ADS-B ground station.

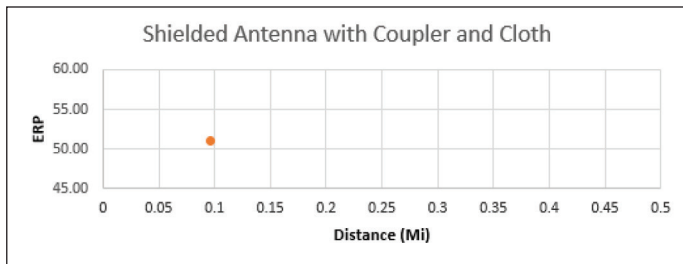
TCAS systems will detect the ADS-B squitter and then interrogate the transponder UUT. With no coupler or RF shield installed, as shown below, the UUT would need to be within 24.8 miles to hear the interrogation, 1.4 miles with a coupler installed, and less than .1 miles with added RF cloth for additional attenuation. If the UUT does not hear the interrogation, then it will not reply. This graph depicts the effectiveness of VIAVI antenna couplers to airborne receivers without being rebroadcast from a ground station.

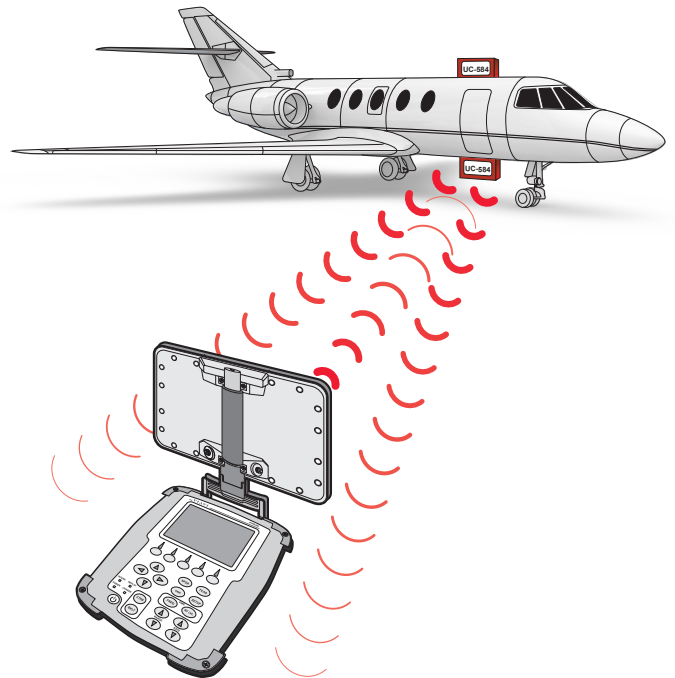
Once you have couplers installed on the transponder antenna's, you can perform a leakage test using the IFR6000 and RF antenna. Verify proper setup and test within 50' of the aircraft's antenna.
